Manhole Inspection Summary

Manhole # S29S__017MH

Insp Date: **10/31/08 8:56 AM**

Location Address: **1900 Bayard St**

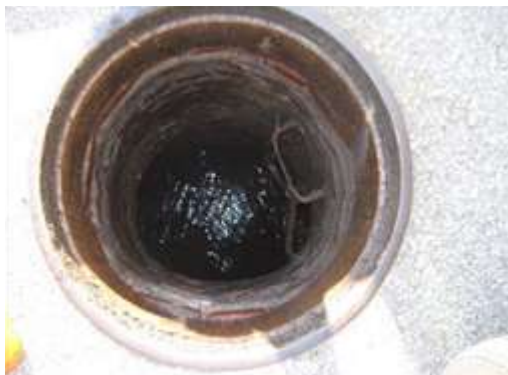
Miscellaneous

frame view

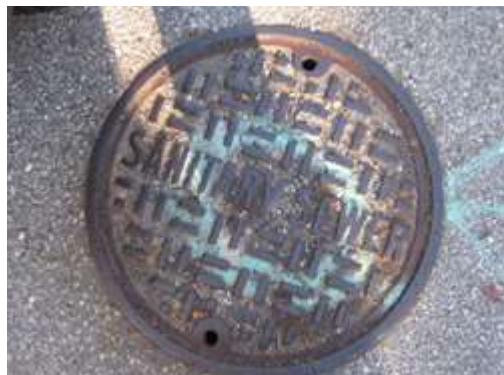
misc-2

cover lid

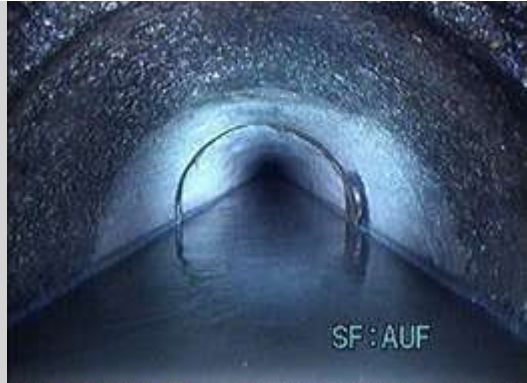
12 O'Clock Outflow

39 in. Circular Gravity Sewer
Pipe Out @ 12OClock

Pipe Height: **36** (in.) Rod and Bar (Angled)
Pipe Material: **Clay** ☐ Pipe Lined
Invert Depth: **13.51** (ft.) Flow Characteristics: **None**
Deposits: ☒ None ☐ Mud ☐ Sludge ☐ Debris ☐ Grease
Silt Depth: **0** (in.) Deposits Extent:
Infiltration: **None** Pipe Seal Cond: **Sound**

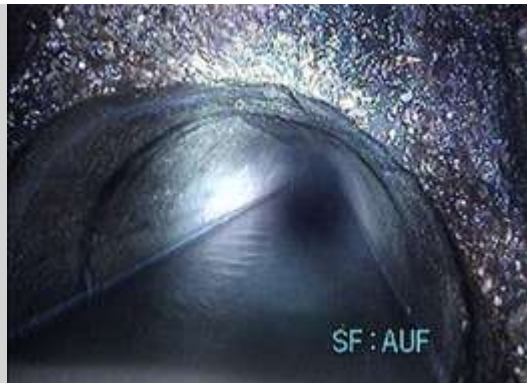
6 O'Clock Inflow

39 in. Circular Gravity Sewer
Pipe In @ 6 OClock

Pipe Height: **36** (in.) Rod and Bar (Angled)
Pipe Material: **Clay** ☐ Pipe Lined
Invert Depth: **13.47** (ft.) Flow Characteristics: **None**
Deposits: ☒ None ☐ Mud ☐ Sludge ☐ Debris ☐ Grease
Silt Depth: **0** (in.) Deposits Extent:
Infiltration: **None** Pipe Seal Cond: **Sound**

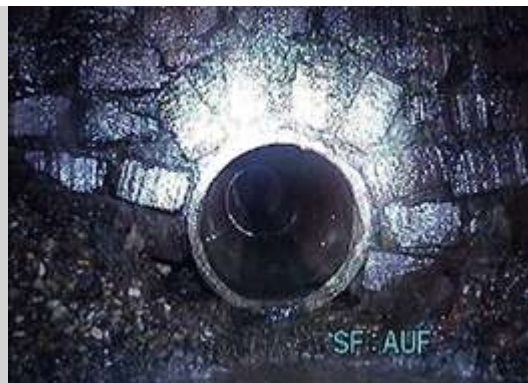
9 O'Clock Inflow

8 in. Circular Gravity Sewer

Pipe In @ 9 O'Clock

Pipe Height: **8.4** (in.) Rod and Bar (Angled)

Pipe Material: **Clay** ☐ Pipe Lined

Infiltration: **None** Pipe Seal Cond: **Sound**
